## Old Castle Road, Weymouth

Landslide Inspection May 2020

Dorset Council

**Old Castle Road Landslide Inspection May 2020**

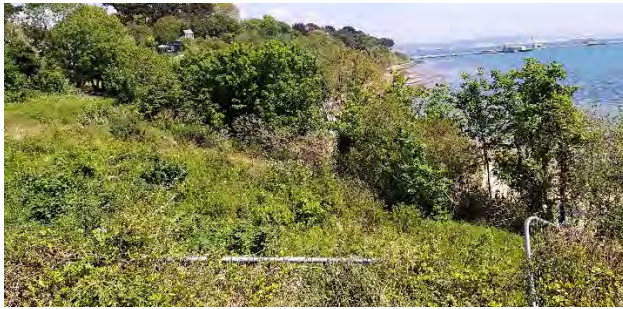
5. The failure has transported heavily-vegetated debris, including trees, downslope and onto the rear of the beach. Fencing and a hut at the southern end of the site have also been displaced (see Photos 3 and 5).

6. Toe heave has occurred close to the base of the slope. This is backed by compression ridges of displaced material as evidenced by the exposure of yellowy brown sandy clay in Photo 4.

Photo 3. Vegetated and compressed landslide debris in the mid to lower slope. Toe heave is evident close to the trees near the base of the slope.

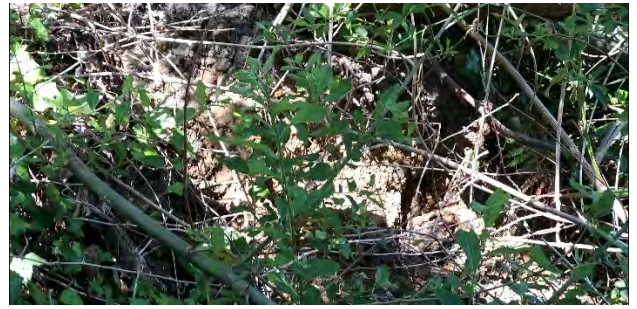
Photo 4. Exposure of Lower Sandsfoot Grit in zone of toe heave close to the base of the slope.

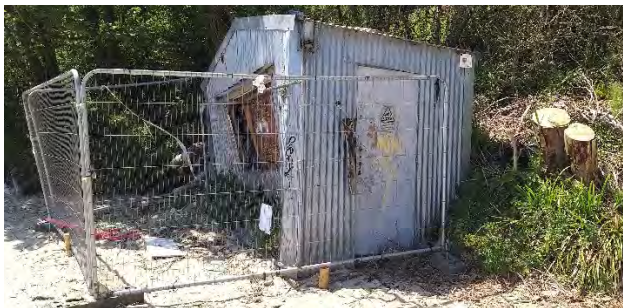
Photo 5. Hut at the southern end of the site has been displaced seaward and twisted by the landslide debris.

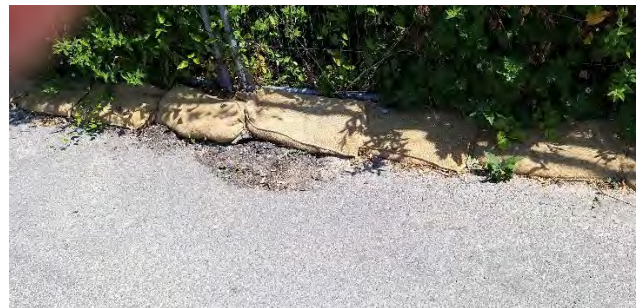
Photo 6. Sandbags placed along the edge of Old Castle Road to prevent water from entering the landslide headscarp. Evidence that the road edge has been affected by subsidence.

- Emergency installation (*i.e.* before the wet weather returns later in the year) of a high, continuous kerb stone replacing the sandbags currently situated along the roadside. Although the sandbags help direct water away from the landslide, a kerb stone will intercept and divert a greater proportion of surface water, preventing it from entering the landslide system. Care will need to be taken not to disturb the cliff edge when installing the kerb stone.

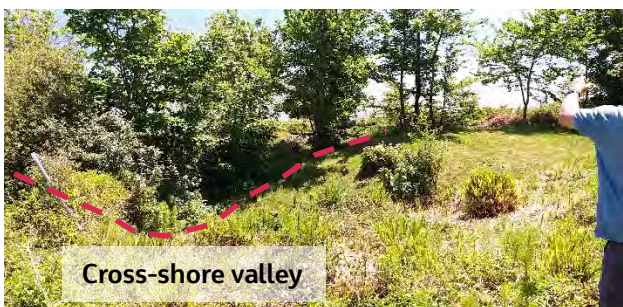
Photo 7. Shallow cross-shore valley separating the debris of the recent landslide at No. 23 Old Castle Road and the existing landslide to the south.

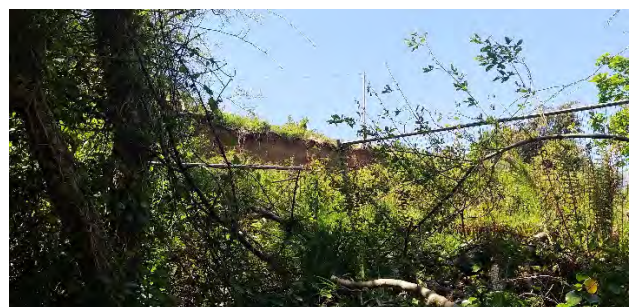
Photo 8. View upslope to the headscarp across vegetated debris through the centre of the landslide from 3 m above beach level.

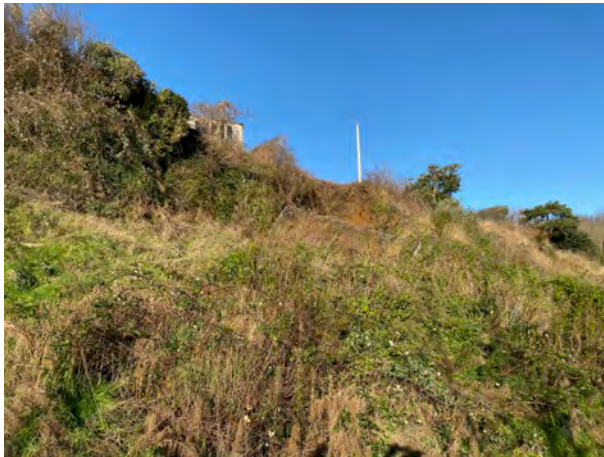
4. There is photo evidence that the failure began in January 2020, peaked in early March following a prolonged period of heavy rainfall and is still moving (see timeline Photos 8 to 14).

Photo 8. 19th January 2020. Scarp begins to open up at the southern end of the site in response to translational failure below.

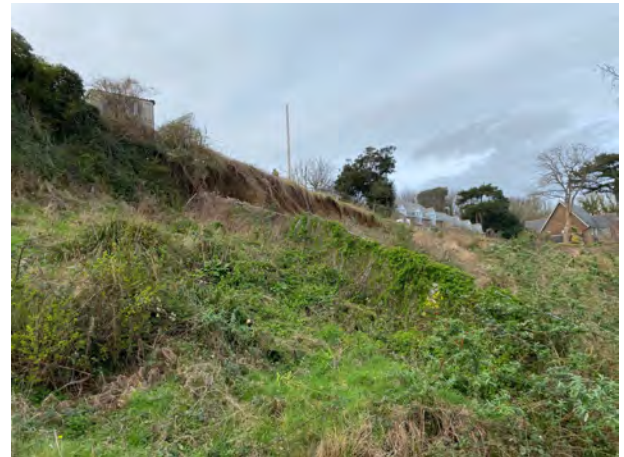
Photo 9. 23rd February 2020. Scarp extending northwards and growing in height as translation failure below continues.

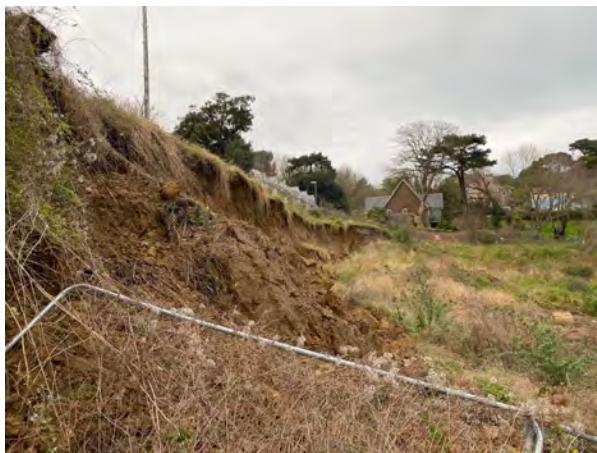
13. The new failure has the potential to spread upslope and laterally.
- The headscarp is oversteep and unstable. There is evidence of ongoing small-scale cliff falls which could retreat the headscarp and breach Old Castle Road (see Photo 10).

- The loss of the remnant spur (see Appendix 1) and large cliff fall in the south of the site (see Photo 10) may have reduced support to the adjacent cliff at number 25 Old Castle Road. This area may become unstable.

Photo 10. 5th March 2020. Further significant displacement of translational failure and growth of headscarp height. Cliff fall debris from the overstep scarp is visible in the foreground.

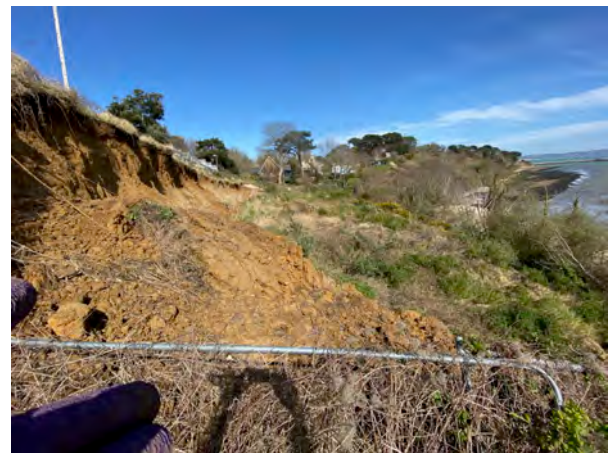
Photo 11. 22nd March 2020. Continued but slowing of translational failure and scarp development. Amount of cliff fall debris growing.

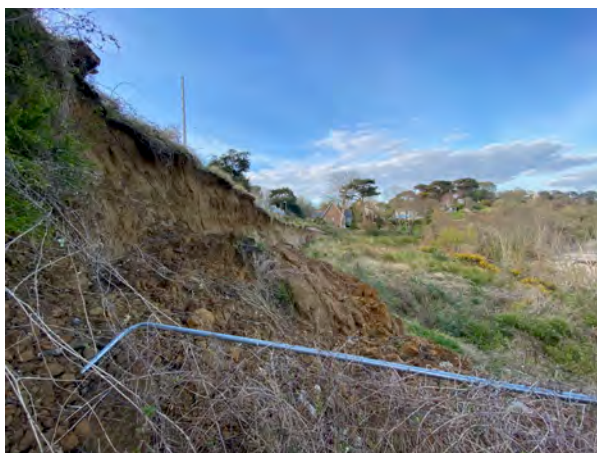
Photo 12. 3rd April 2020. Further continued slow translational failure and scarp development.

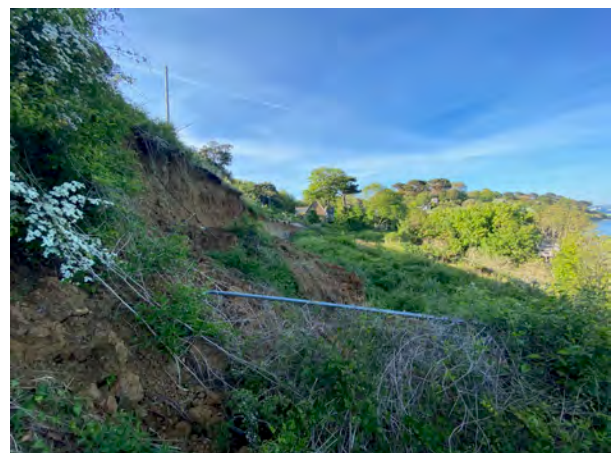
Photo 14. 19th May 2020. Changes to slope becoming disguised by vegetation growth.

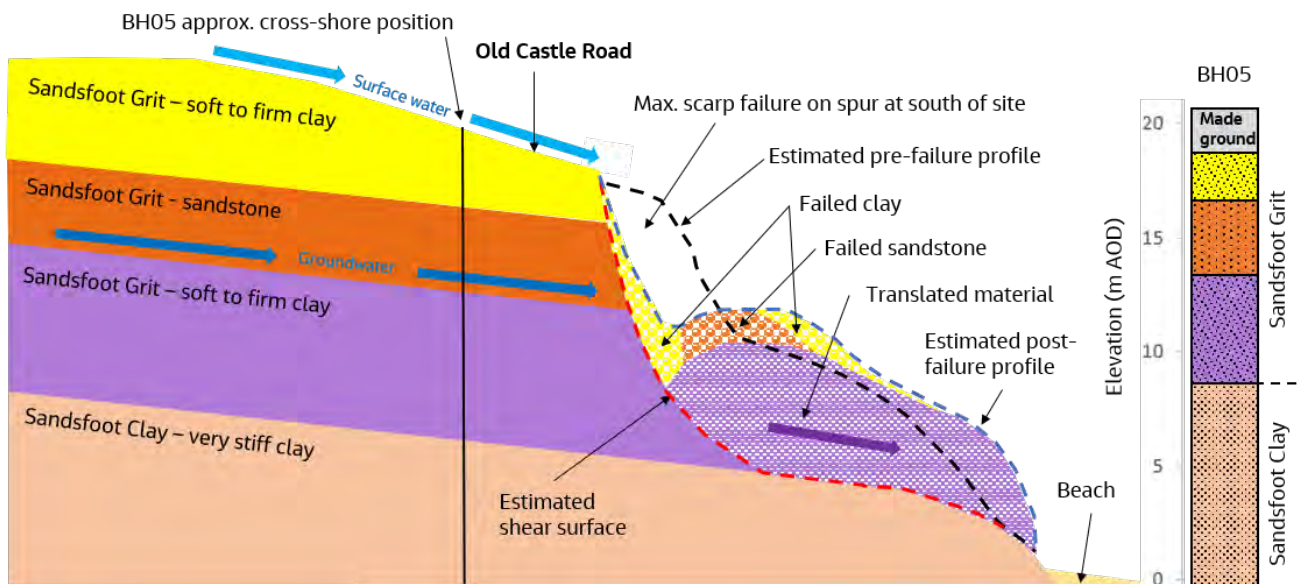
Figure 3. Schematic cross-section showing the geology, landslide geometry and pre and post-landslide slope surface. Note that Borehole 5 is shown in the correct cross-shore position but is located 30 m to the south of the cross-section.

2. The failure has retrogressed the headscarp of the slope to within 2 metres of Old Castle Road (see Photo 1 and geomorphological map in Appendix 1).
3. The failure appears to be along a bedding-controlled shear surface in the soft clay at the base of the Sandsfoot Grit (see cross section in Figure 3).

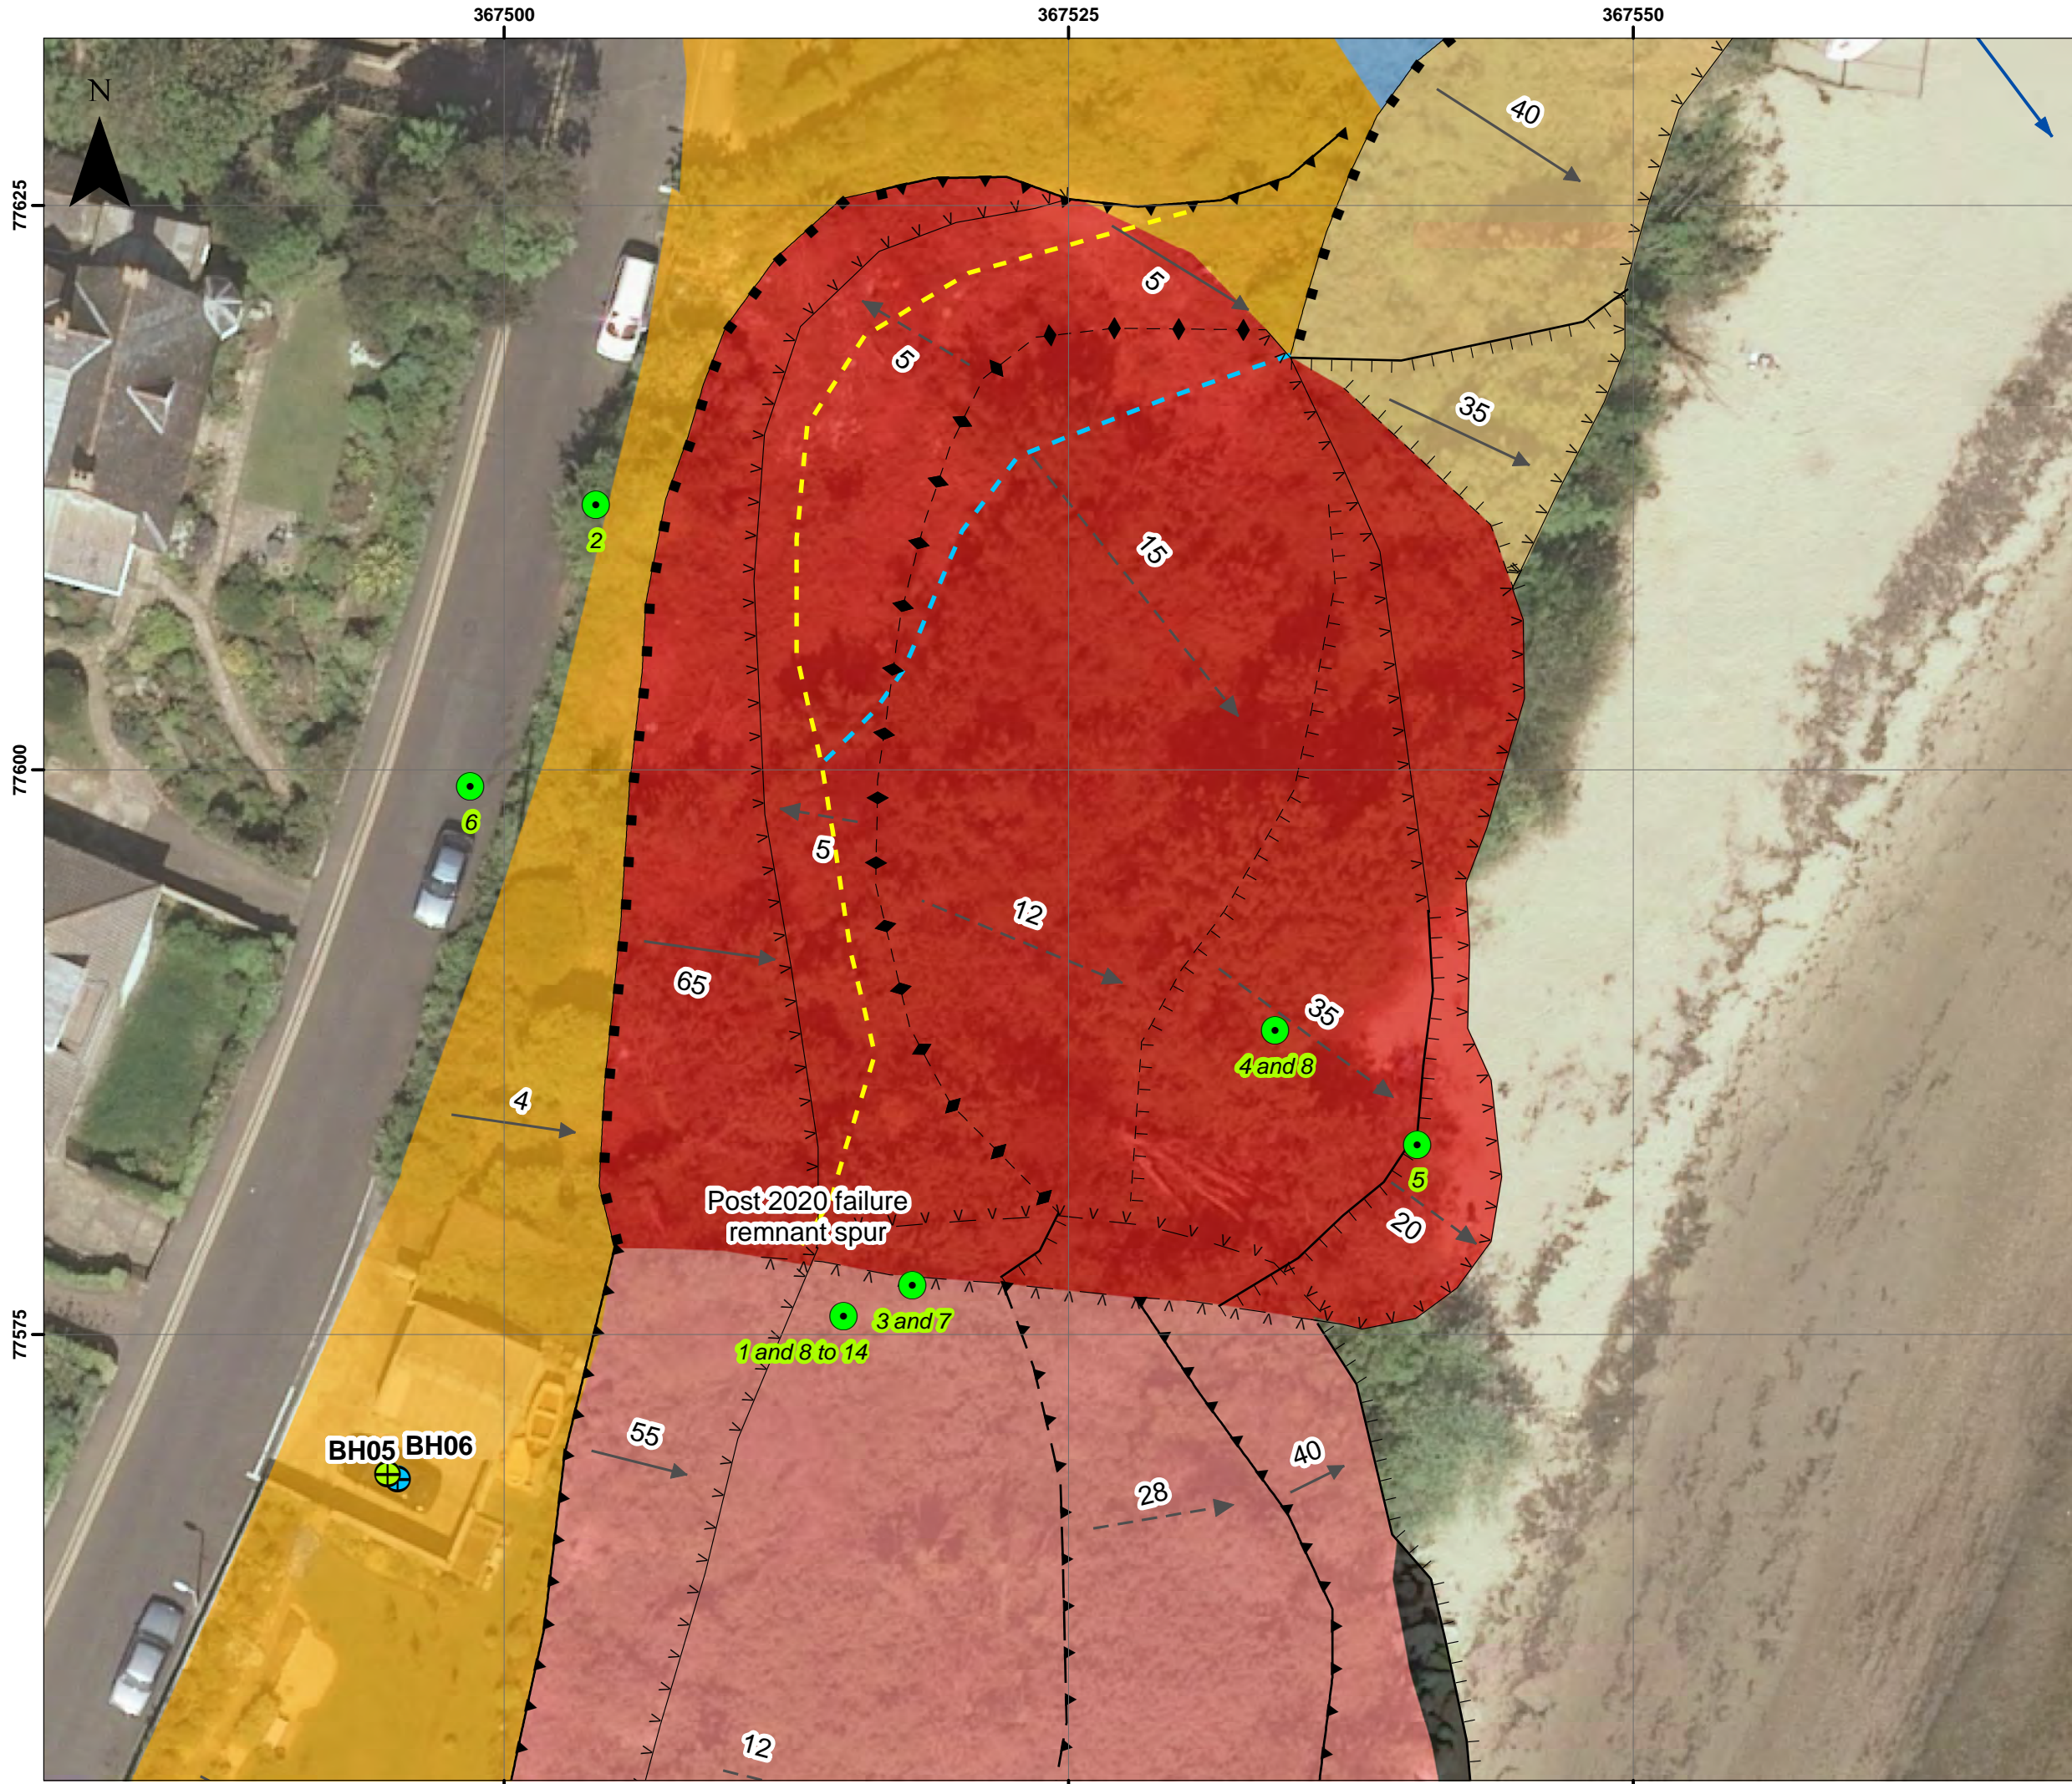
### May 2020 Landslide Mapping and Observations

7. In response to the loss of basal support following movement of the lower slope, up to 7 m of the plateau at the cliff top has failed (see Appendix 1). To the north of the site the plateau loss tapers out.

8. The greatest proportion of this failed material is derived from the remnants of a spur which previously separated the south of the site from no. 25 Old Castle Road (see Appendix 1).
